A survey of St James's Church, Lancaut, Gloucestershire

A survey of St James's church, Lancaut, Gloucestershire

By CHARLES PARRY

Summary

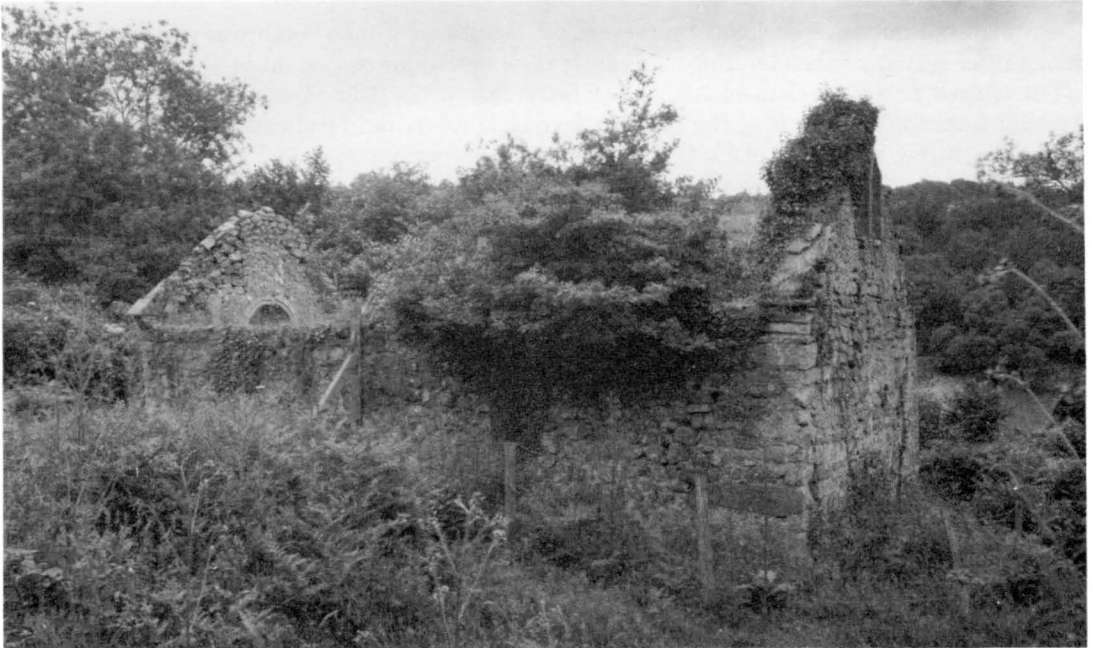
FIG. 9 St James's church; September 1986, before clearance, looking south-east.
Photographed by S. Dorey for Gloucestershire County Council.

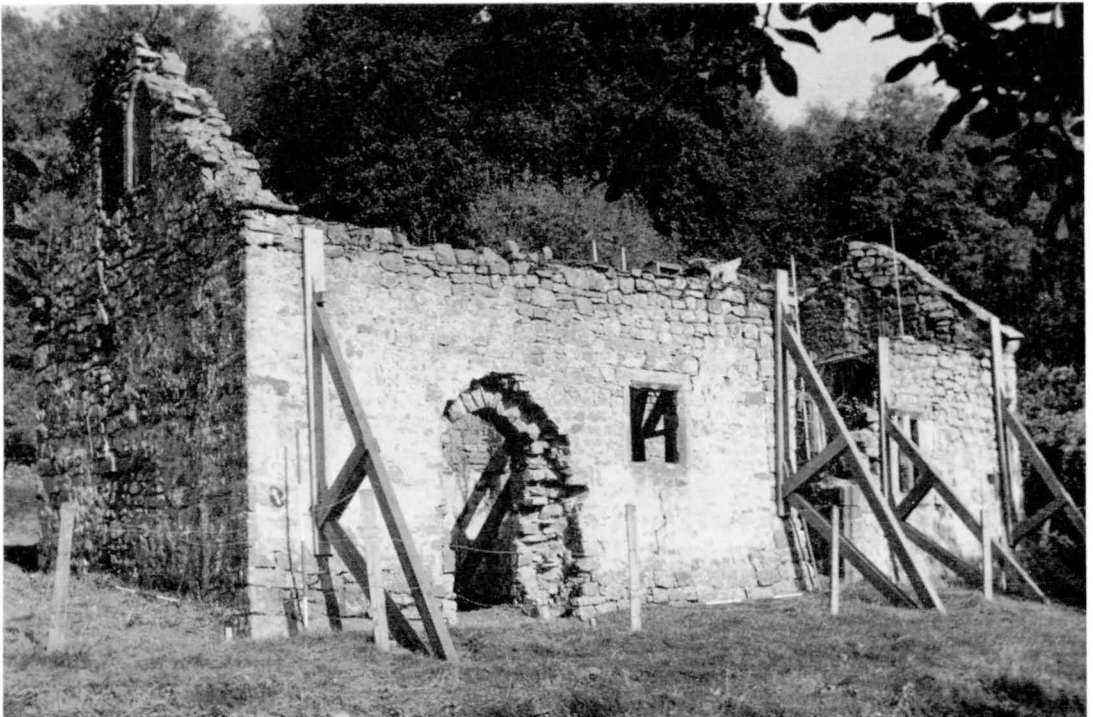
The nave encloses an area of 5.7 m by 4.3 m (maximum) and is entered by a doorway (1.07 m wide) in the south wall. Internally, the doorway surround is of coursed rubble construction. Externally, no doorway-surround is now present (FIG. 10), but a segmentally-arched surround,

FIG. 10 St James's church; October 1986, after clearance, looking north-east.
Photographed by C. Parry.

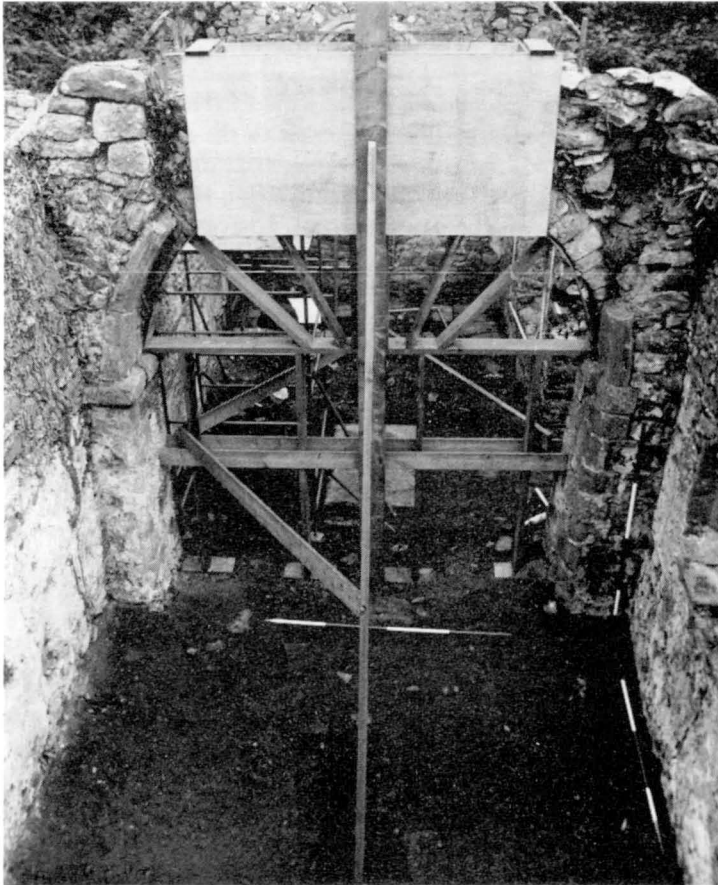
FIG. 12 St James's church; chancel arch and nave interior, 1986, looking east.
Photographed by C. Parry.

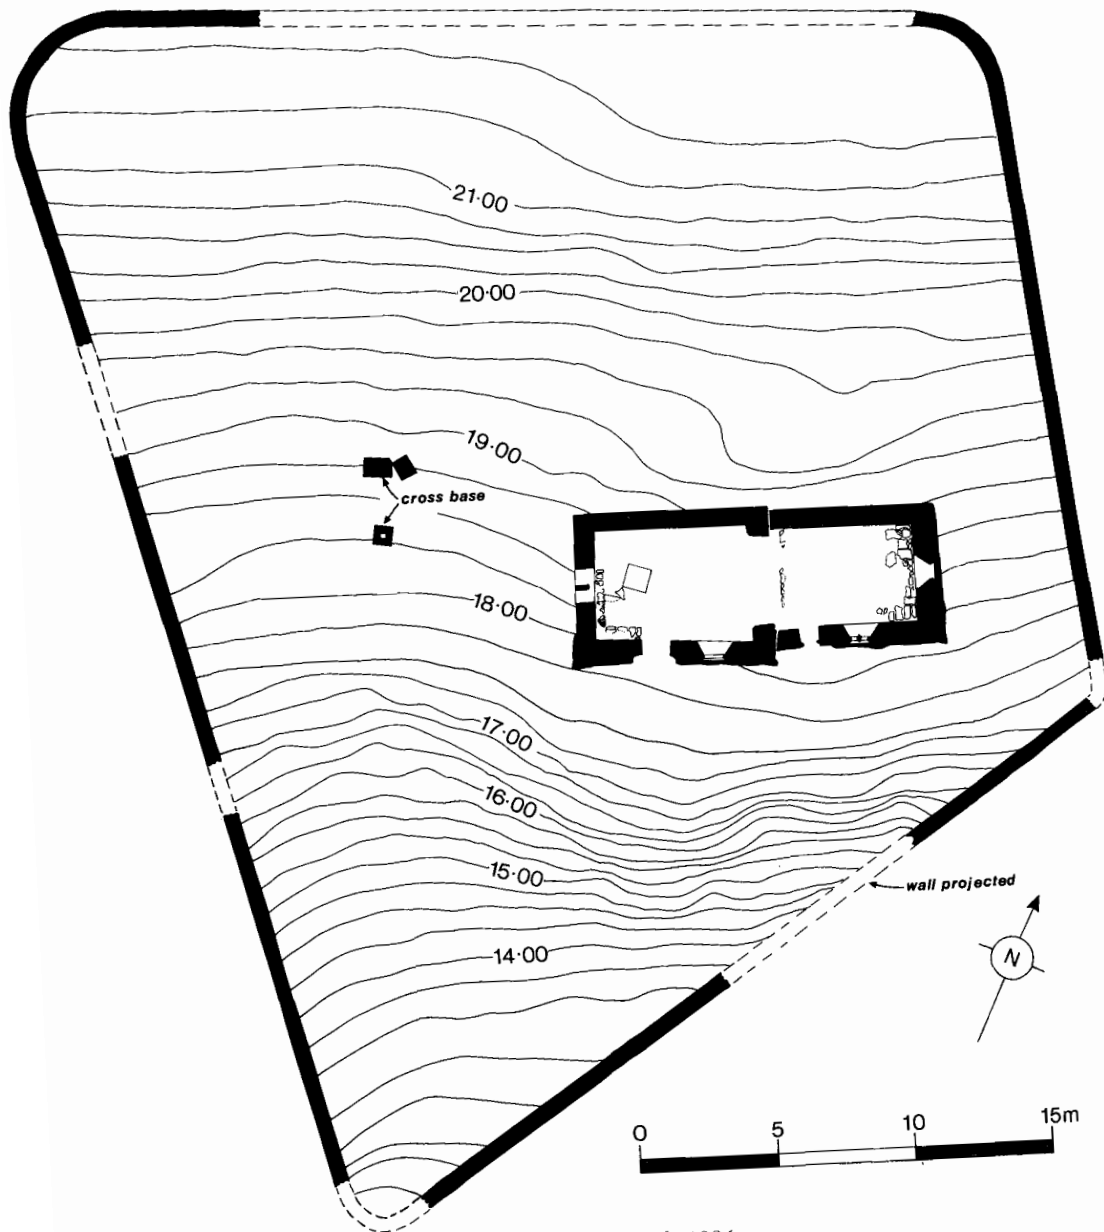
FIG. 14 St James's church; contour survey of churchyard, 1986.

The churchyard had achieved its present form by 1815 (Glos R.O. P333a SD 1/1: enclosure map), but construction of the wall which now surrounds it may post-date c. 1840, for drawings of this date (*Ormerod* [13], FIG. 2; [14]) suggest that the churchyard was then enclosed with a wattle fence. The churchyard-wall is very dilapidated, having almost completely fallen on the north, and is in need of repair on the south, east, and west.

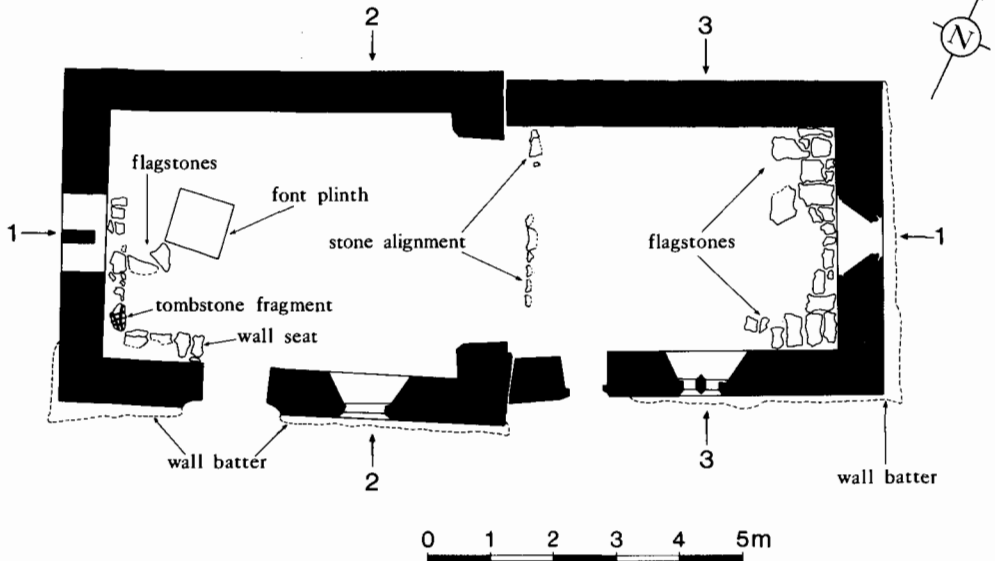
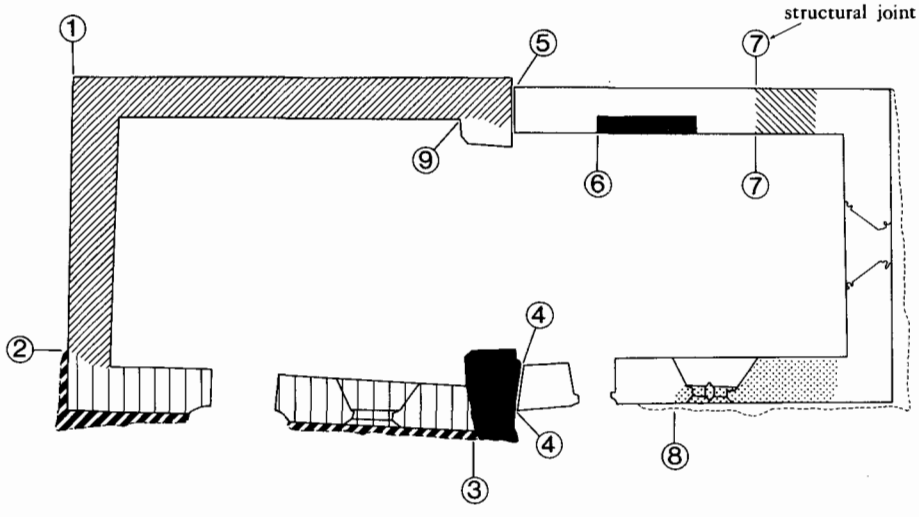
mortar types and structural joints

Nine structural joints (Joints 1–9) indicating the presence of adjoining, but chronologically distinct, constructions were identified. The location of each joint is indicated on the elevation drawings, marked with a dotted convention where the junction is not obvious (FIGS. 15–17), and additionally indicated on plan (FIG. 18). Qualifying statements made in the following descriptions regarding the visibility of some of the evidence should be noted. The relative chronology of each joint is summarized by TABLE II. Working progressively eastwards from the west wall of the nave these are:

Joint 4 — This is situated at the junction of the south walls of the nave and chancel, and is of particular importance because of the information revealed there by the collapse of the chancel wall. Corework projecting from the nave (i.e. the arch abutment; Fabric 2) indicates that at one time the nave masonry was carried on into the chancel area with no break in construction. This earlier chancel was presumably replaced by the present chancel (Fabric 4), represented by the stub of its collapsed wall butting up against the corework of the arch abutment. Internally, a tiny portion of the earlier chancel is visible at ground level, and this projects slightly, but not significantly, forward of the elevation which replaced it.

Joint 5 — Joint 5 is the northern counterpart of Joint 4, formed by the junction of the north wall of the chancel (Fabric 4) and the northern abutment of the chancel-arch (Fabric 1). As at Joint 4, the chancel is the later of the two constructions, as it abuts the nave masonry, a relationship also observed at Joint 9. Unlike Joint 4, there is no evidence that the chancel-arch abutment was at one time bonded into a chancel, for within Joint 5 there is a gap wide enough to show that the northern abutment has a faced elevation, and that this is, apparently, coated with a layer of rendering.

Joint 7 — On the north wall of the chancel, near its junction with the east wall, is an U-shaped joint, visible both internally and externally due to the use of a mortar which contrasts with the mortar bonding the surrounding fabric. The masonry inside the U (Fabric 6) is a repair to the collapsed aumbry area, and rests on top of Fabric 4.

Joint 8 — In 1986 it could be observed that the south window of the chancel and the wall above (Fabric 5) had been partly reconstructed, being later in date than the chancel masonry (Fabric 4). The construction was shoddy, and the resulting break in the masonry was recorded before this portion of wall was dismantled and subsequently reinstated as part of the consolidation process in 1988.

Joint 9 — The description of Joint 9 has been left until last because it was visible only after careful plotting of the mortars used in the adjoining constructions. The presence of Type 4 mortar proves that the northern jamb of the chancel-arch, and a considerable portion of the masonry above its western side, were reconstructed at the same time as the chancel (Fabric 4). The structure of the arch (Fabric 2) does not appear to have been disturbed during this work. A few stones bonded with Type 4 mortar are also adjacent to the arch-jamb on the north wall of the nave, where they replaced stonework bonded with Type 1 mortar. This evidence confirms the later dating of the chancel masonry with the northern abutment of the chancel-arch, observed at Joint 5.

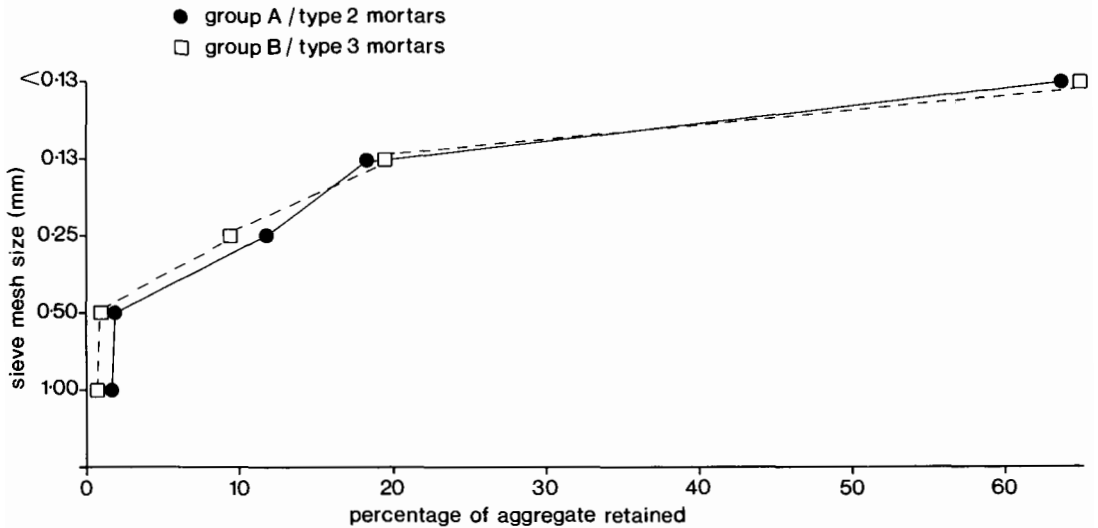
FIG. 27 St James's church; mortar analysis.
 Sand fractions, particle size distribution of mortar groups A and B.

However, the close similarity of aggregate sizes present in each group suggests that the mortars were related in use, and may be indicative of two, broadly contemporary, phases of construction.
